UNITED STATES ENVIRONMENTAL PROTECTION AGENCY

MEMORANDUM

Subject: *Crossland Facility Inspection Report*

Inspection Date: August 19, 1998

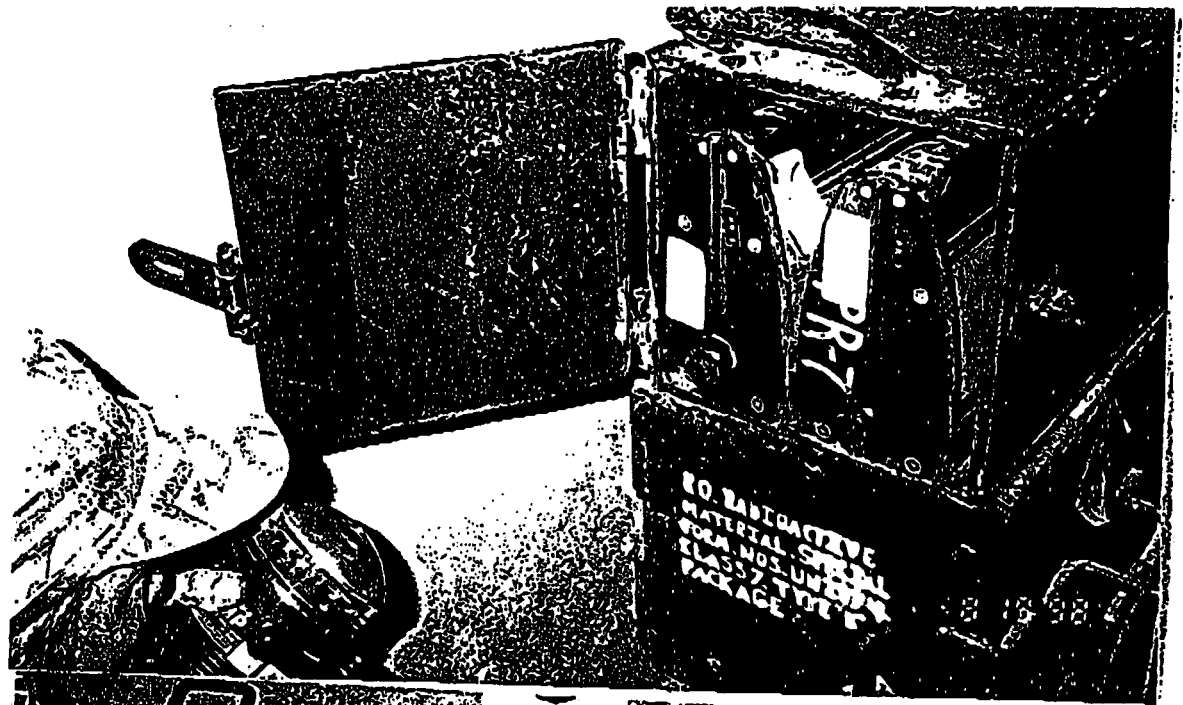
Cobalt 60 camera

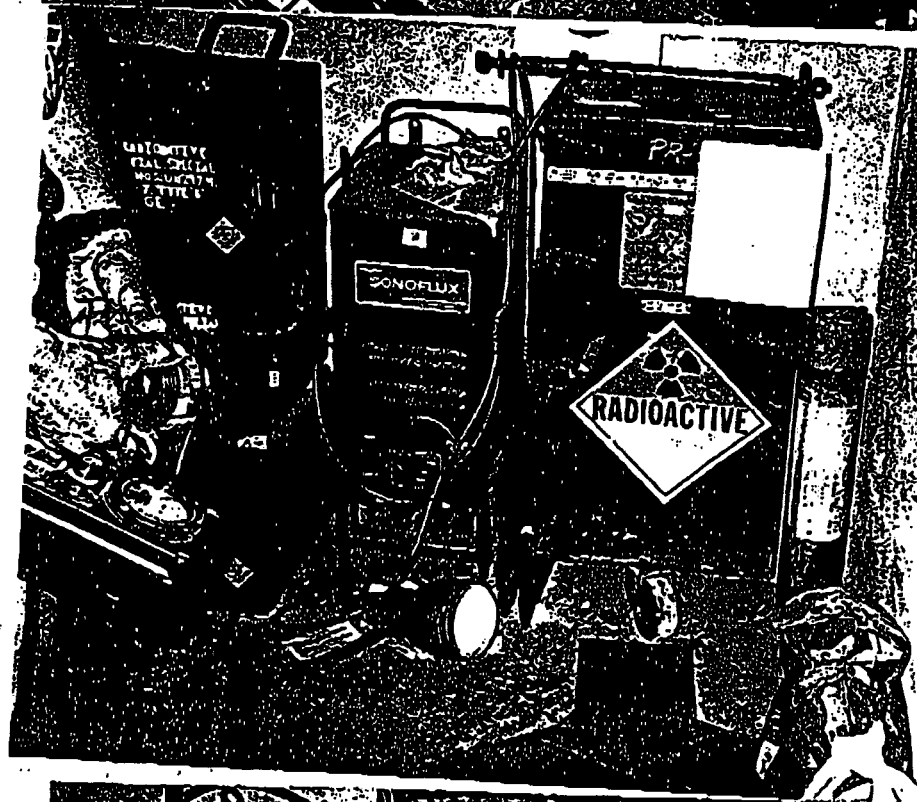
Cobalt 60 camera
